ISS GLOBAL / DAILY INCIDENT INVESTIGATION

Hanoi: fatal restaurant explosion

Casualty reconciliation, structural damage and an unresolved cause

ISSUE DATE
2026-11-25

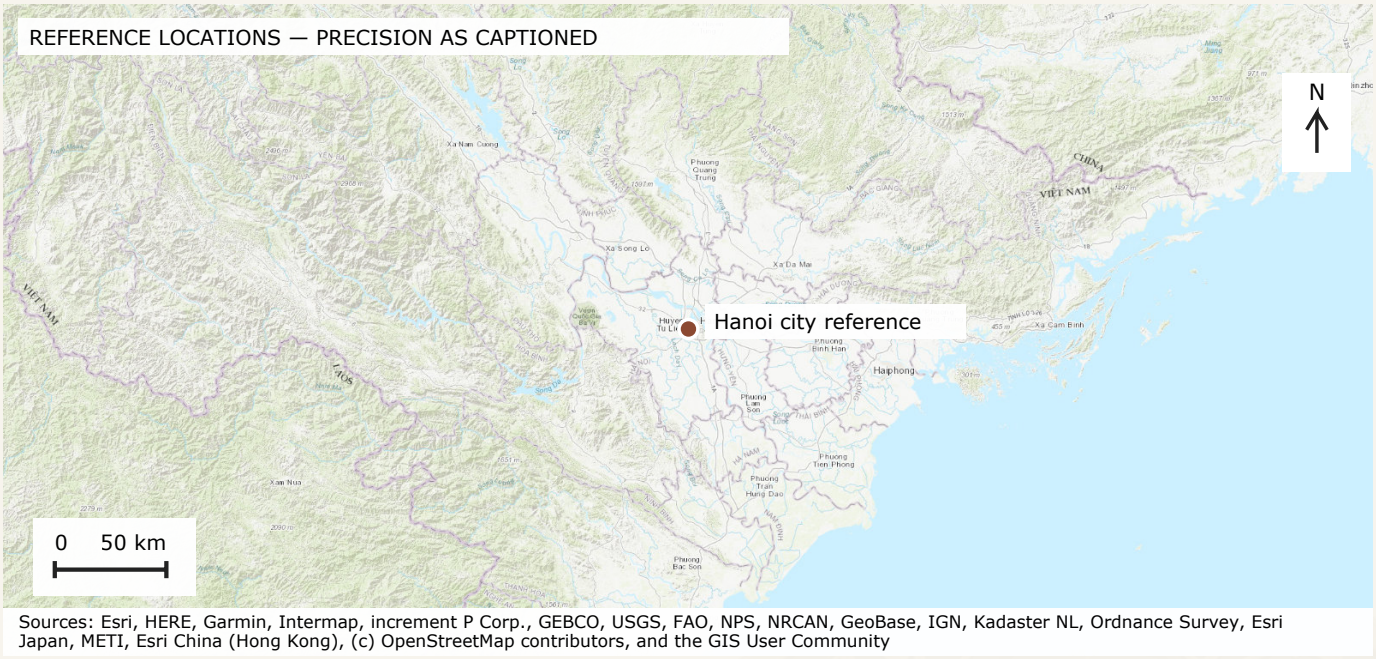
The later VNA account carried by Nhan Dan describes parts of the E4 apartment block collapsing, eight fire and rescue vehicles and more than 60 responders. It says police received the report at about 08:03. The government account gives an initial notification time near 08:05; the difference is retained, not converted into an exact response interval. [3] [1]

DTiNews, citing Hanoi's health authorities, reports six fatalities and ten people receiving emergency treatment as of 13:00. It also describes nine ambulances and 36 medical workers, with some patients initially presenting with respiratory failure and multiple injuries. [4]

Assessment: the reviewed record establishes a serious explosion and rescue operation. It does not establish an exact point of initiation, recovered cylinder identity, ignition mechanism, responsible individual or criminal intent. There is no supported IED identification.

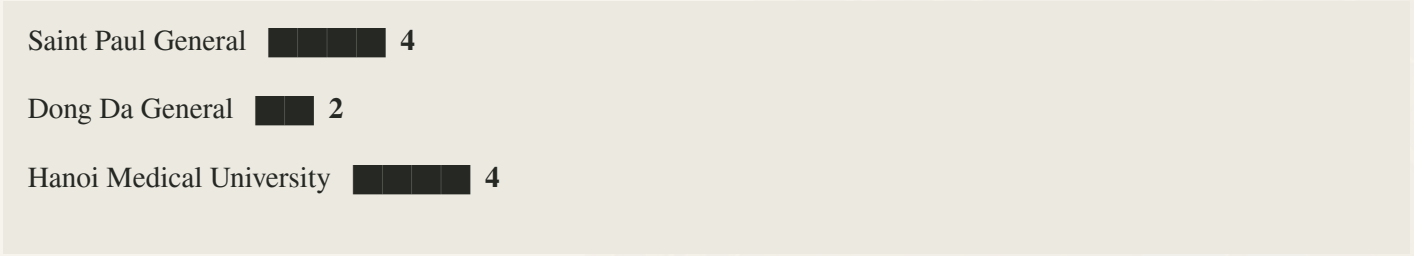
Reported distribution of ten injured patients

One block represents one patient. Hospital allocation as reported at 13:00 ICT; not a severity, capacity or outcome comparison. [4]
