ISS GLOBAL / DAILY INCIDENT INVESTIGATION

# Stanhope Street attack

North Belfast · suspected pipe-bomb attack

2026-10-16

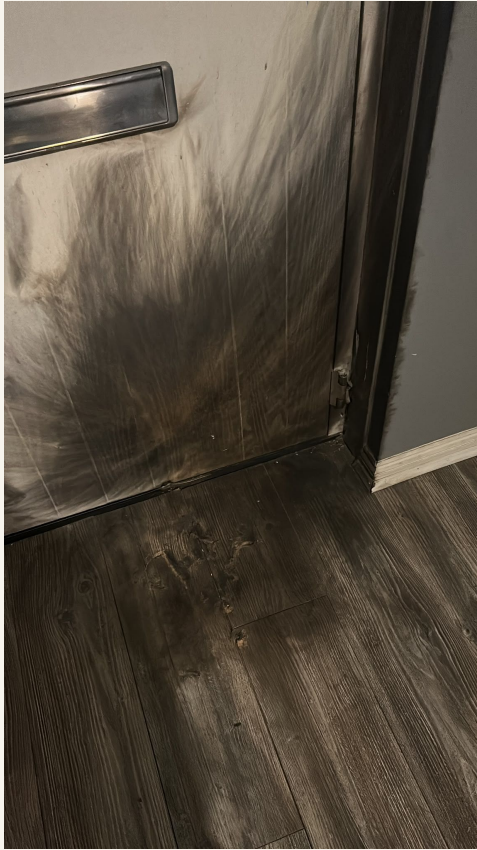
Plate 1. Interior doorway and floor, published by Belfast Media on 16 October. Photographer unnamed; a corresponding handout image appears in the BBC report. <sup>[1]</sup>[4]

The frame shows dark deposits across the inner door surface, local disruption around the lower hinge/edge and irregular damage to the floor immediately beside the doorway. A letterbox is visible higher on the door.

These observations document the appearance of the published scene. They do not identify the explosive, its quantity, a particular container fragment or the exact point of functioning.

The image is consistent with the reporting of damage at the entrance. Its evidential value is strongest as a visual record of surfaces and their relationship to the doorway; it is weaker as a basis for reconstructing the device. There is no scale, systematic coverage or accompanying examination record.

A competent examination could establish which marks and materials are associated with this event and which samples, if any, were taken. The public photograph alone cannot establish that a hole was caused by added fragmentation rather than another mechanism. No device remains are assigned an identity from this image.
